# **Remedial Documentation Report**

## **Navy Pier**

### **600 East Grand Avenue**

**Subject: Remedial Documentation Report for Navy Pier, 600 East Grand Avenue, Chicago, Illinois, AECOM, Inc. Project No. 60312502**

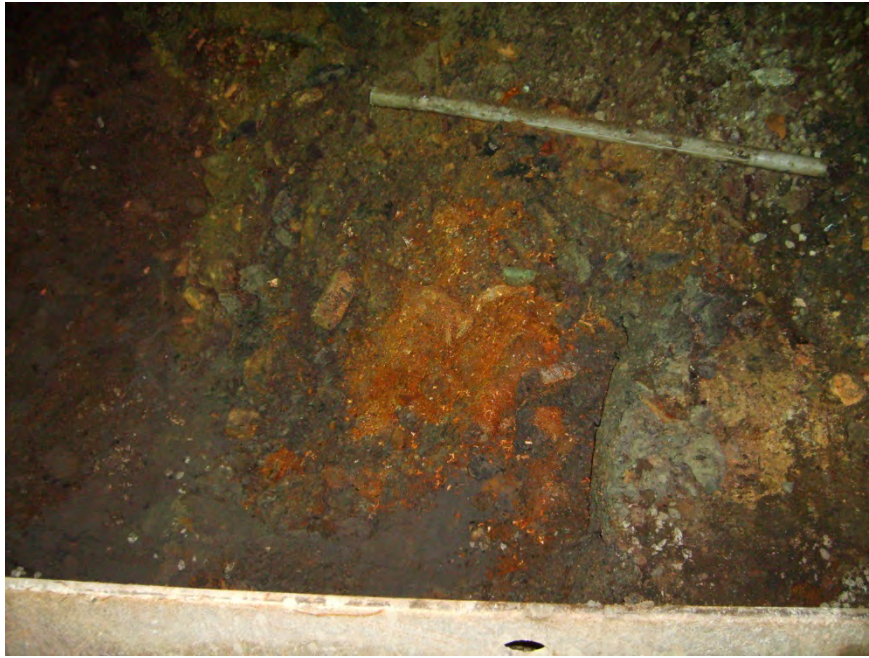
1. Reddish orange radiological contaminated material at the base of the remedial excavation.

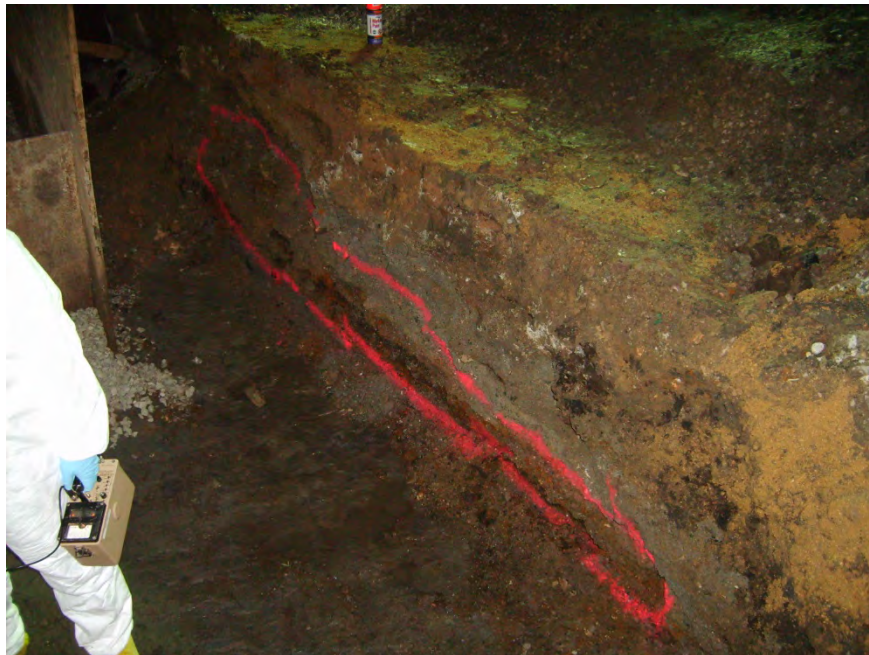
2. The western wall of the remedial excavation where radiological contaminated material was left in place beneath the ComEd Duct Bank.

It was not possible to remove contaminated soil from beneath the duct bank without potentially undermining the duct bank. Therefore, in consultation with the USEPA at the Site during the remedial activities, it was agreed that the contaminated materials would be left in-place. The shielded gamma readings for a majority of the contaminated area ranged from 6,700 to 11,000 cpm shielded. These gamma counts measured in the western wall were substantially less than those observed for the remediated material, which ranged from 25,000 to 65,000 cpm shielded. The shielded gamma count for the instrument threshold equivalent to the USEPA cleanup value of 7.1 pCi/g is 6,137 cpm.

Previously (on April 18, 2014) a 9-foot long test pit was excavated along the western side of the duct bank. The test pit depth extended below the duct bank to the depth at which the contamination had been originally observed east of the duct bank. Gamma readings measured by AECOM within the test pit, and for spoil in the excavator buckets from the test pit, did not indicate elevated gamma readings at the base of the test pit. However, gamma measurements along the eastern wall of the test pit (i.e., beneath the western side of the duct bank) did indicate slightly elevated gamma readings or shine from contaminated soil beneath the duct bank. Thus, the contamination left in-place is confined to a thin layer beneath the duct bank. Based on these observations it is estimated that the contamination is confined to an area below the duct bank with the dimensions of approximately 1-foot thick, 3-feet wide and 12-feet long (approximately 1.3 cubic yards).

As indicated in Section 2.4, not all of the radiologically-contaminated fill soil was able to be removed. Excavation near the ComEd concrete duct along the western edge of the remedial excavation identified radiological contaminated material beneath the duct bank. Removal of the material could not be completed without risking damage to the ComEd electrical lines. Figure 1 shows the location of the area of contamination remaining on-site. The contaminated area was approximately 12-feet in length and 1-foot thick. Since it does not extend west of the duct bank (which is approximately 3-feet wide), the volume of fill soil remaining in-place is estimated at 1.3 cubic yards. This contaminated fill soil is located beneath the duct bank at a depth of approximately 5-feet below the ground surface. A photograph (#2) in Appendix E shows the location of the contamination outlined with red paint following the completion of the remedial activities.

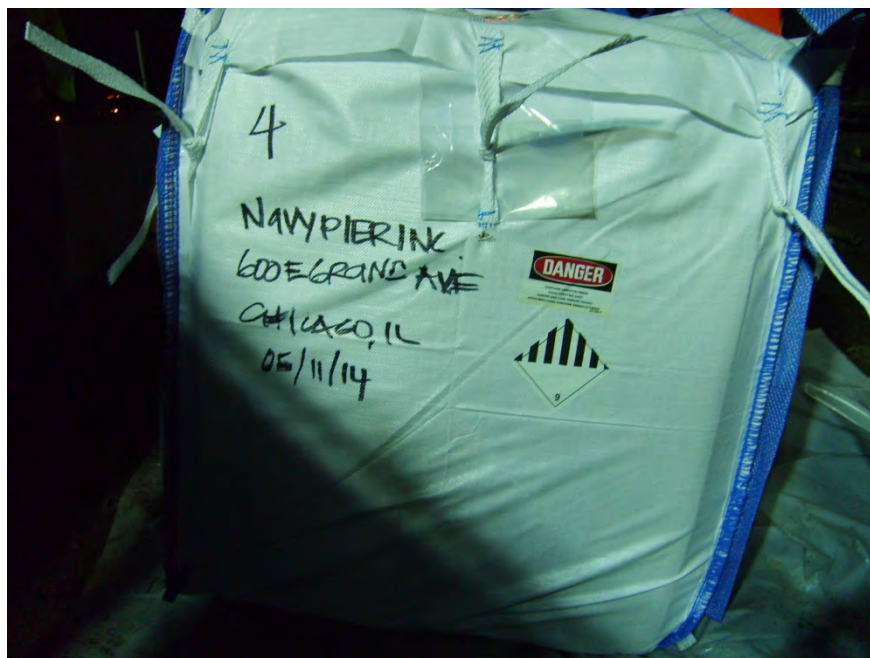
3. Super Sack used to store the radiologically contaminated material.

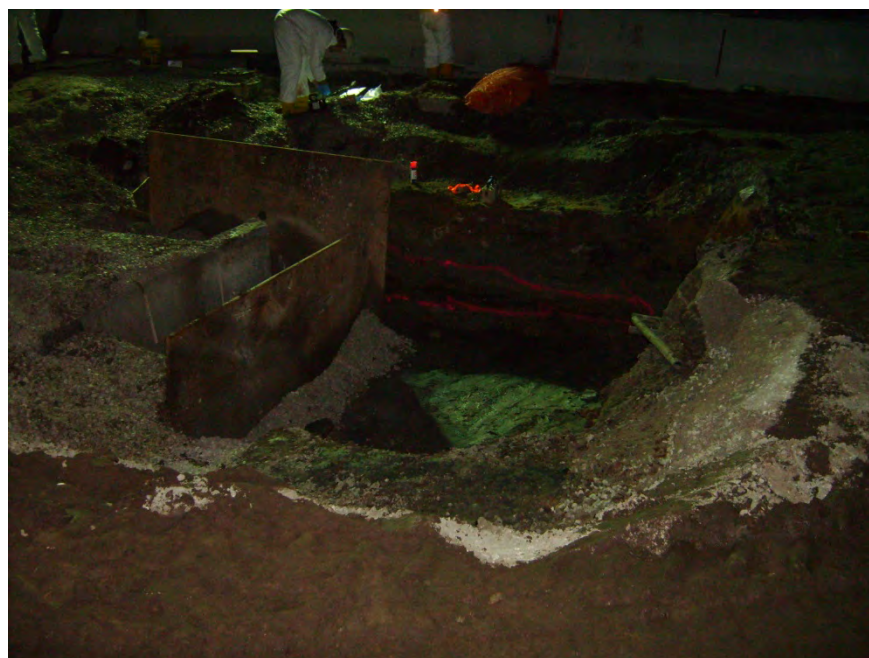
4. View of the remedial excavation nearing completion.
